## **Wing-Damage Index Used for Characterizing Wing Condition of Bats Affected by White-nose Syndrome**

**Jonathan D. Reichard**  
**Center for Ecology and Conservation Biology**  
**Department of Biology**  
**Boston University**  
**Boston, MA 02215**

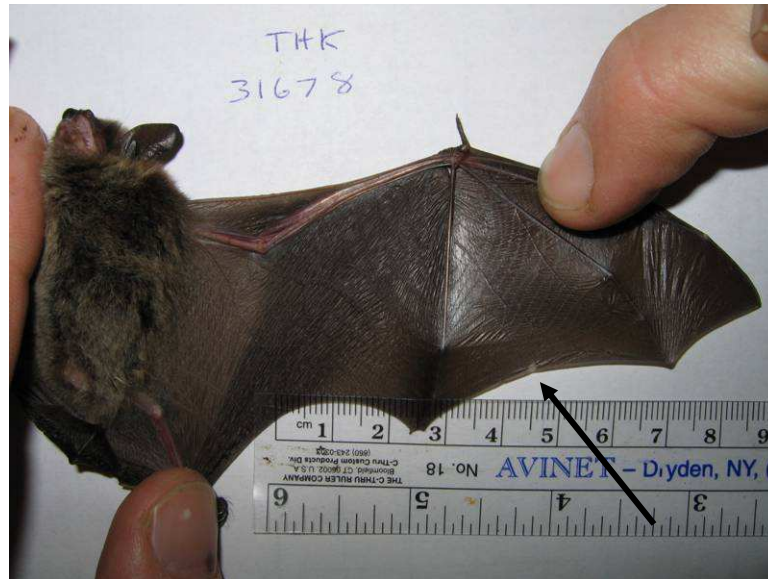
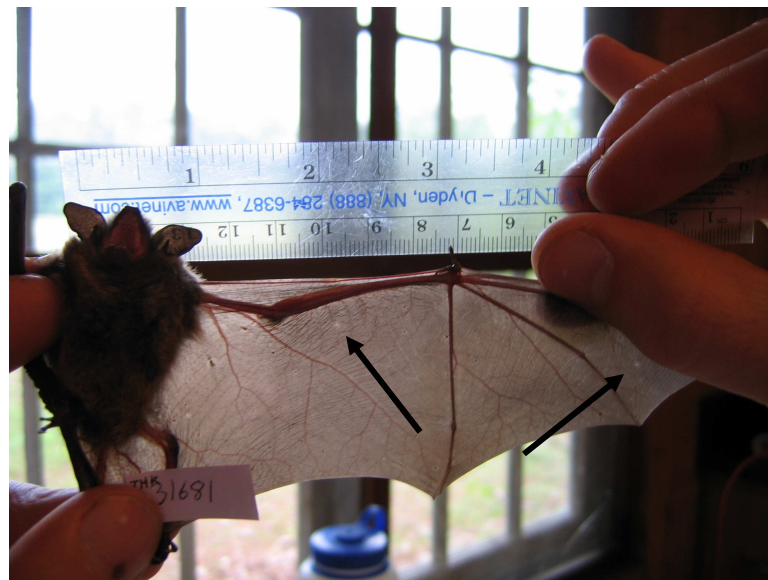
**Score = 0** *No damage.* Fewer than 5 small scar spots are present on the membranes. The membranes are fully intact and pigmentation is normal.

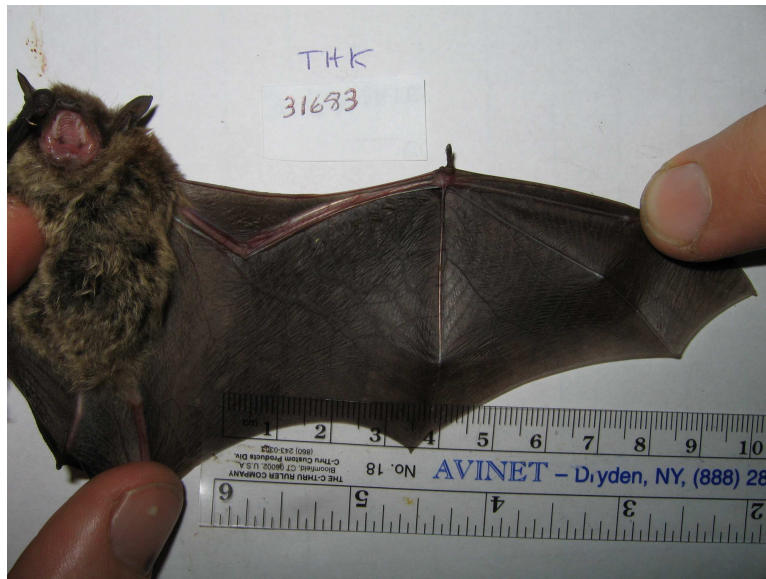
*Light damage.* Less than 50% of flight membrane is depigmented (spotching), which is often visible only with translumination. The membranes are entirely intact. Some discoloration or flaking is visible on forearms. Such flaking on the forearm may exist even if the patagium appears unaffected.

Note: no spotching visible with only front lighting.

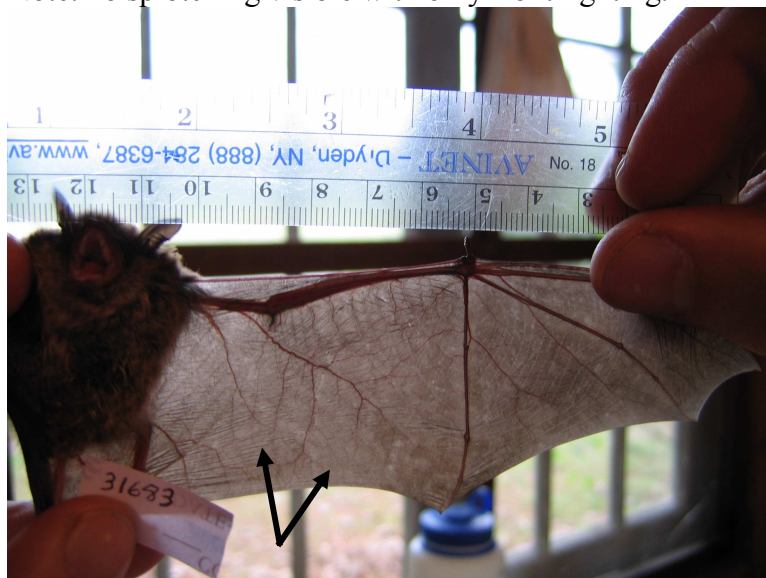
Translumination reveals the splotchy flight membrane.

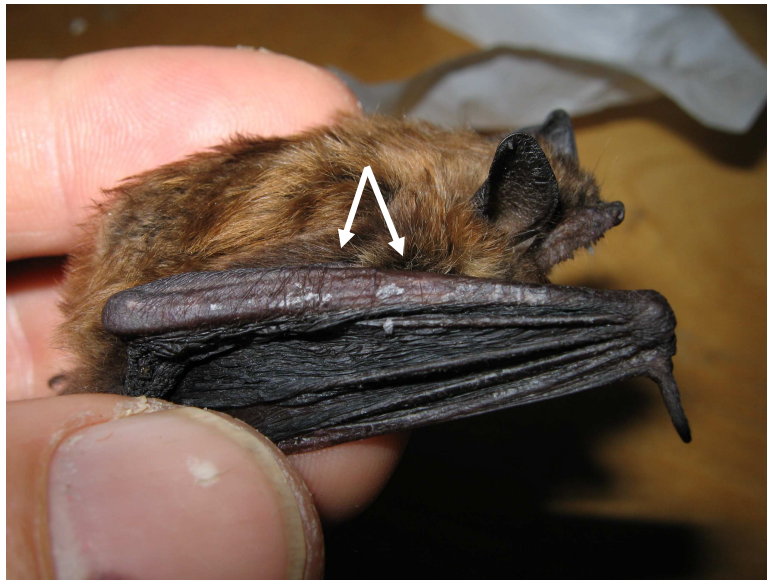
Forearms may have flaking skin or discolored areas.

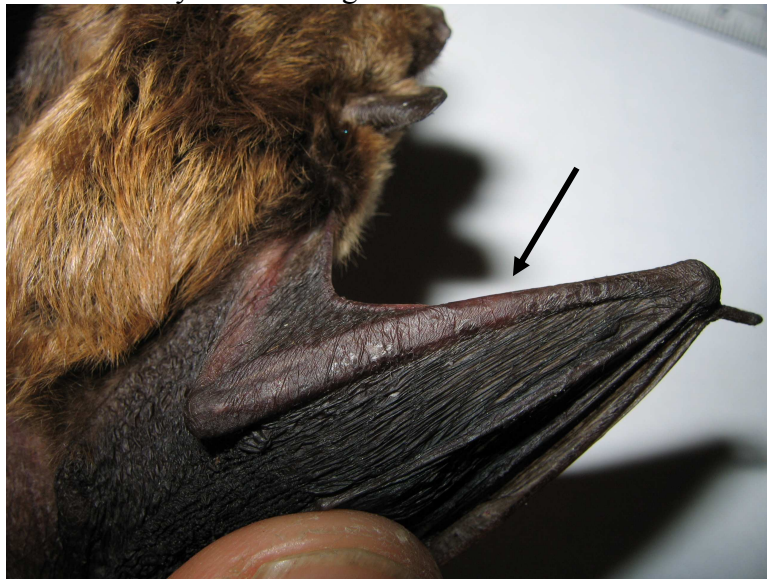
**Score = 2** *Moderate damage.* Greater than 50% of wing membrane covered with scar tissue (splotching). Scarring is visible without translumination. Membrane exhibits some necrotic tissue and possibly few small holes (<0.5 cm diameter). Forearm skin may be flaking and discolored along the majority of the forearm, but this condition alone *does not* earn this score level.

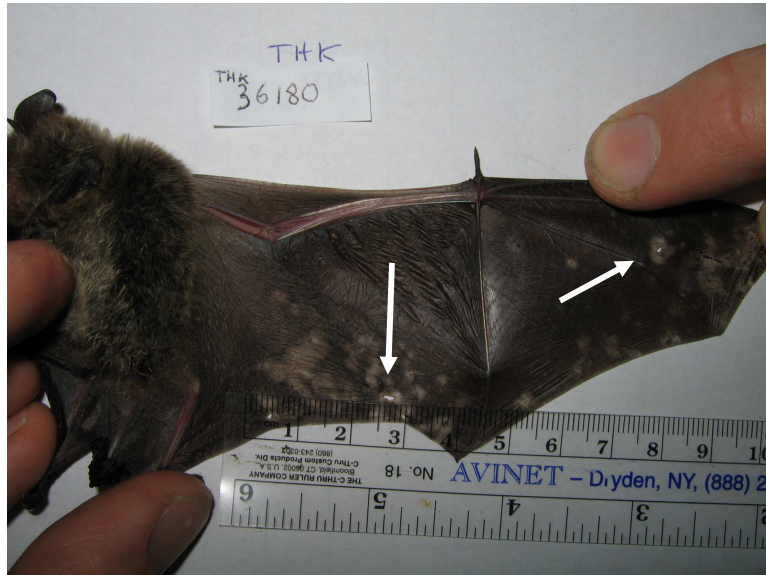
Small holes are surrounded by discolored tissue. Necrotic tissue is sometimes associated with less severe splotching.

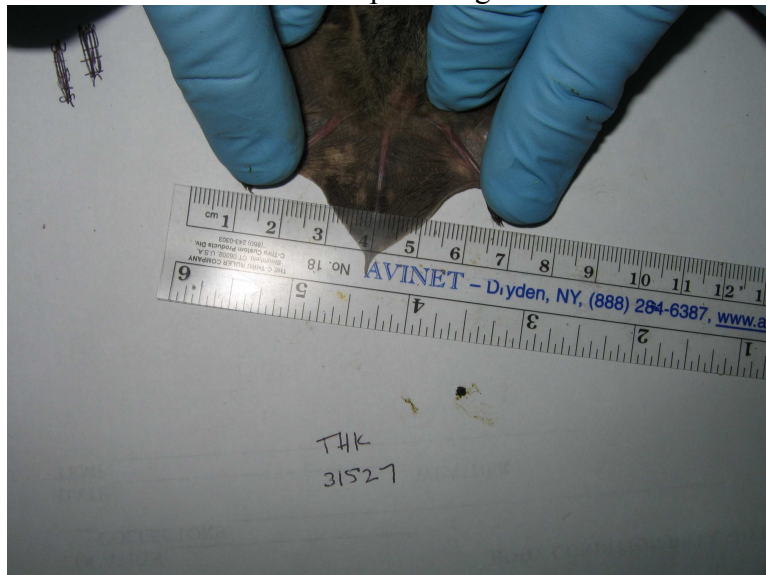
*Heavy damage.* Deteriorated wing membrane and necrotic tissue. Isolated holes  $\geq 0.5$  cm are present in membranes. Necrotic or **receding plagiopatagium** and/or chiropatagium are evident. This score is characterized by notable loss of membrane area and abundant necrosis.

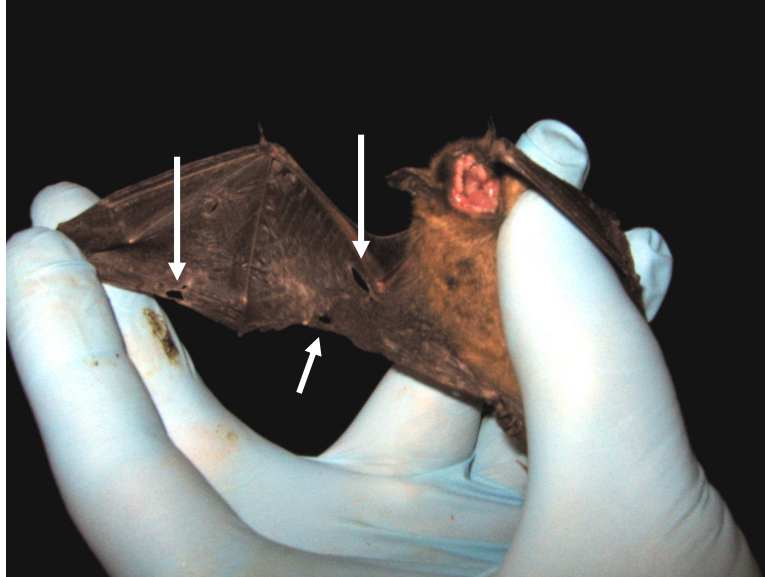
Flight membranes show damage similar to level 2 damage with additional loss of flight membrane area due to holes and/or receding edges of the wings.

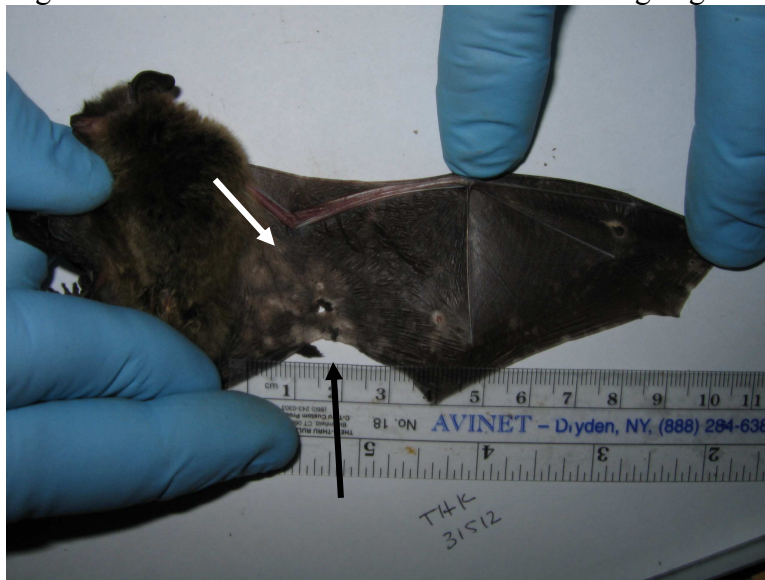
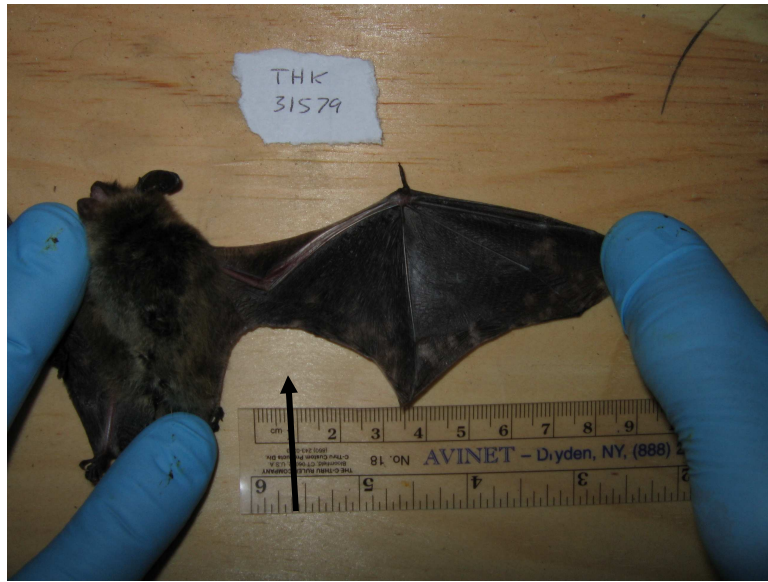
Plagiopatagium loss may be severe.

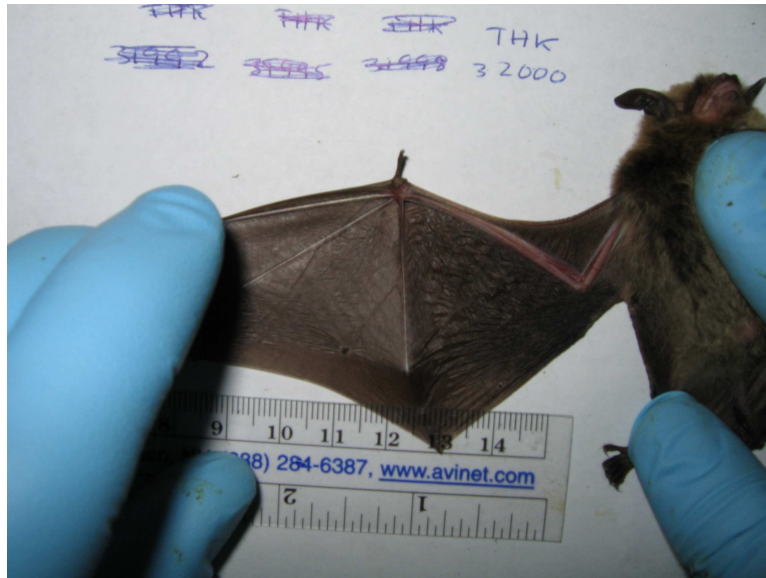
Example: **Score = 1-P** due to light splotching (not shown in photo) and a physical tear in the membrane. **Description:** Right plagiopatagium appears to have torn from trailing edge of the membrane to about 1

cm proximal to the elbow.

We have encountered bats that have obvious physical damage to wings, but no associated splotching or necrotic tissue. These conditions are important to document as well. We suggest these be recorded in concordance with the above scores followed by a postscript “P” for “physical damage.” For example, an animal which has no noticeable splotching or flaking, but does have a tear in the wing membrane would be scored “0-P.” An animal that has moderate splotching and a tear or puncture would be scored “2-P.” Along with these scores, a description of the physical damage should be included on the data sheet.

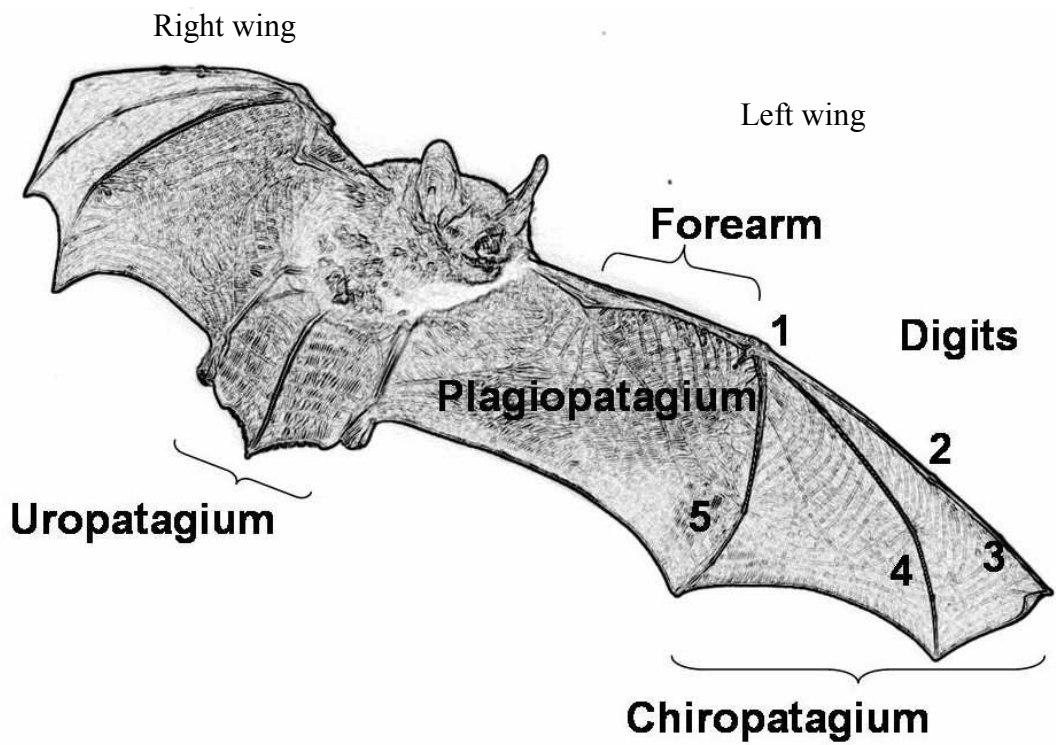
Appendix A: Reference for flight membranes and digits of bats. Image adapted from J. S. Altenbach's photograph of *Myotis thysanodes*.

White-nose Syndrome (WNS) is characterized by the growth of one or more species of fungus on the rostrum, ears, and flight membranes of hibernating bats. During the warm months of the year, damage to these membranes may be manifested by the appearance of necrotic tissue, tears, and scars in these membranes. To assess the occurrence and severity of damage to flight membranes, researchers authorized to handle bats should inspect the membranes of both wings and the uropatagium for each bat handled. Each bat is assigned a single score based on the collective condition of these membranes as described below. Affected membrane areas are estimated as the percent of the total membrane area (including both wings and the uropatagium). Translumination of membranes helps to reveal damage that is not otherwise visible. Damage also has been observed on the forearms of some bats and has been included in these scoring criteria. A general diagram of bat anatomy is included in Appendix A for reference.

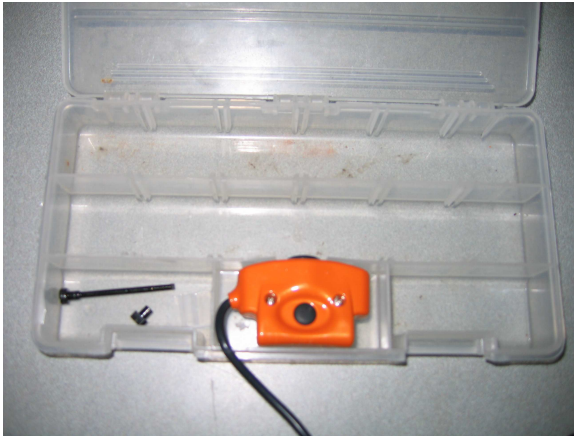
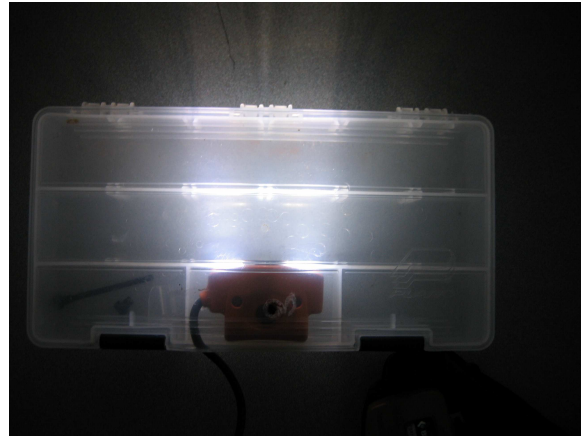
**Appendix B:** We are working with an inexpensive light box in the field. The following model is an early effort to create an inexpensive, transportable light box for transluminating wings. The Plano Stowaway tacklebox insert (~\$3.00) is a good size and the headlamp in this model may be replaced with small LED keychain lights (~\$3.00 each).

The 23 cm x 12 cm tackle box insert is cut to fit the light of a headlamp, creating a diffuse light source.

The damage to membranes and the forearms are scored 0 (none) to 3 (high) according to the criteria listed below and digital photographs are taken to document any damage. Each photograph should include a **reference scale** and the **bat ID number** (specimen number if collected dead or band or ID number if alive and released). Place the **animal on its back on a flat surface with wings and leg extended**. Record images of both wings and the uropatagium either simultaneously or individually. This is best accomplished if one person grasps the tips of the wings and spreads them fully, while a second person extends the bat's legs and uropatagium with one hand and takes the photo with the other. Alternatively, each wing and the uropatagium can be photographed separately, making sure that each photo includes the reference scale and ID number. You may need to experiment with camera settings to achieve quality images; we have had success recording images of flight membranes using a Canon PowerShot A95 (5 MP) digital camera against a white background using the Macro setting, a low intensity, built-in flash, F7.0, shutter speed = 1/800. These settings highlight some of the pspotching and all of the necrosis and holes described below. If possible, translumination may highlight more scarring, but this may be difficult in the field. For translumination, we have used a modified Plano Stowaway tackle box insert (translucent white plastic box) with an LED headlamp inside (see Appendix B). If digital images cannot be recorded, sketches of damaged wings will be helpful.

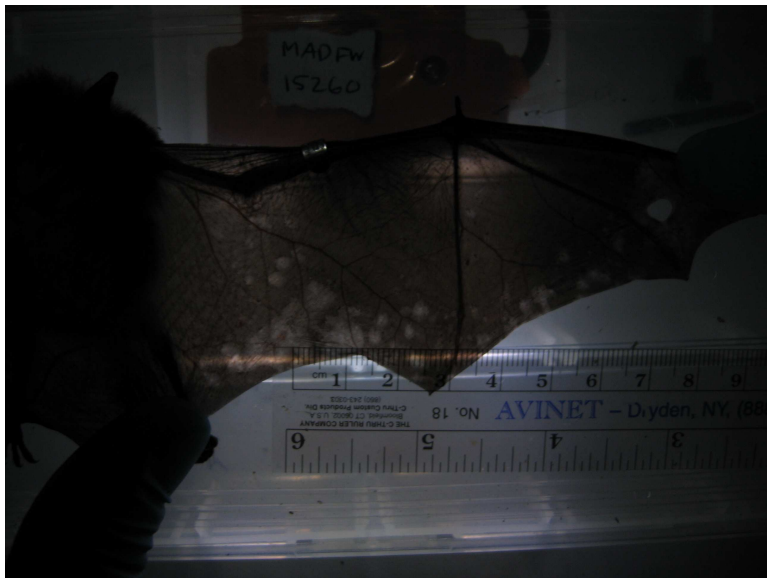
In this model, images are a bit underexposed, but splotching is highlighted nicely. Brighter lights or more LEDs may solve this problem and a tripod would allow for slower shutter speed. This image was taken using F2.8, shutter speed = 1/30.
